Manhole Inspection Summary

Manhole # S25C1_014MH

Insp Date: **4/14/08 3:02 PM**

Location Address: **MAISEL ST.**

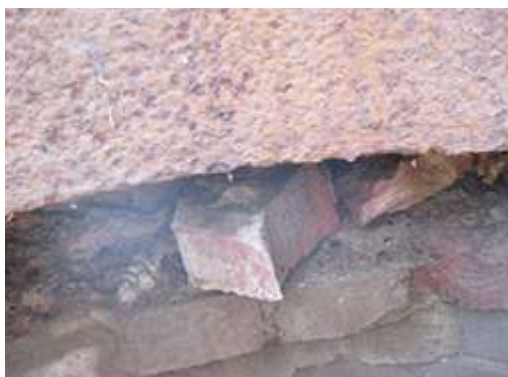
Defect 2

Condition: ☐ Sound ☐ Cracked ☐ Root Intrusion ☒ **Loose Brick** ☐ Deteriorated

Infiltration: ☐ None ☐ Joint ☐ Cracks ☒ **Mortar** ☐ Roots ☐ Wall

EVIDENCE OF INFILTRATION AT CHIMNEY, MISSING MORTAR AND BRICKS

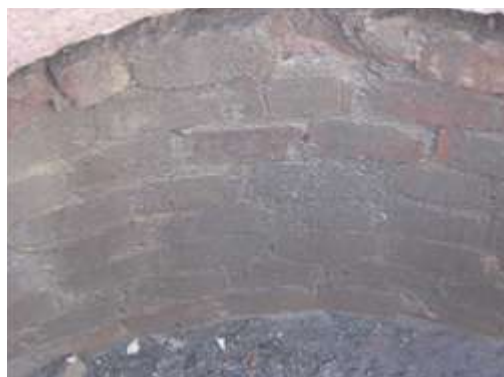
Defect 1

Infiltration: ☐ None ☐ Joint ☐ Cracks ☐ Mortar ☐ Roots ☒ **Wall**

EVIDENCE OF INFILTRATION AT CORBEL AND BARREL, MISSING MORTAR AND BRICK

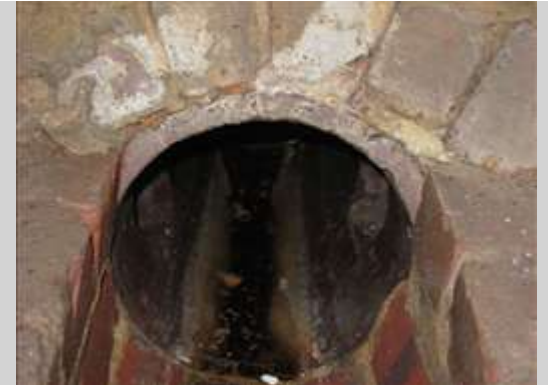
12 O'Clock Outflow

8 in. Circular Gravity Sewer
Pipe Out @ 12 O'Clock

Infiltration: **None** Pipe Seal Cond: **Sound**

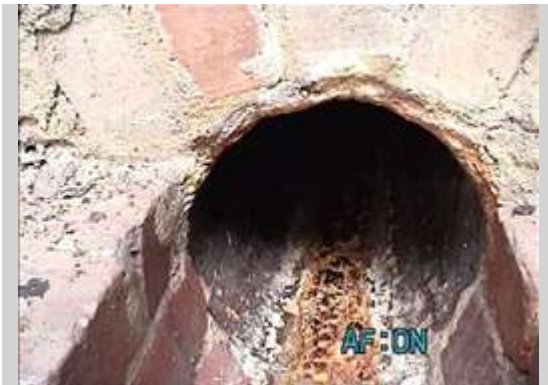
6 O'Clock Inflow

8 in. Circular Gravity Sewer
Pipe In @ 6 O'Clock

Infiltration: **None** Pipe Seal Cond: **Unknown**
